Manhole Inspection Summary

Manhole # S33EE1022MH

Insp Date: **3/6/07 1:38 PM**

Location Address: **3800 39TH ST**

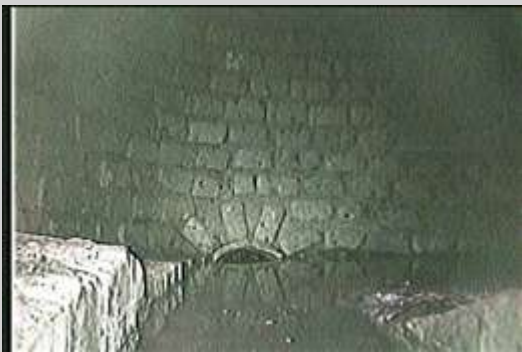
8 in. Circular Gravity Sewer Pipe Out @ 12 O'Clock

Invert Depth: **8.90** (ft.) Flow Characteristics: **Slow**

Deposits: ☒ None ☐ Mud ☐ Sludge ☐ Debris ☐ Grease

Infiltration: **None** Pipe Seal Cond: **Unknown**

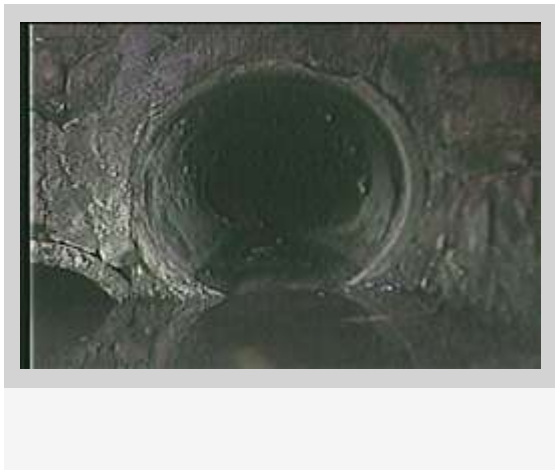
8 in. Circular Gravity Sewer
Pipe In @ 7 O'Clock

Infiltration: **None** Pipe Seal Cond: **Unknown**
